??????? ????? Precitec (OG Y D37 D7, P0595-58601)

Item Code: CS-FB-PW37D7

????????: ??? ??????? Precitec ProCutter

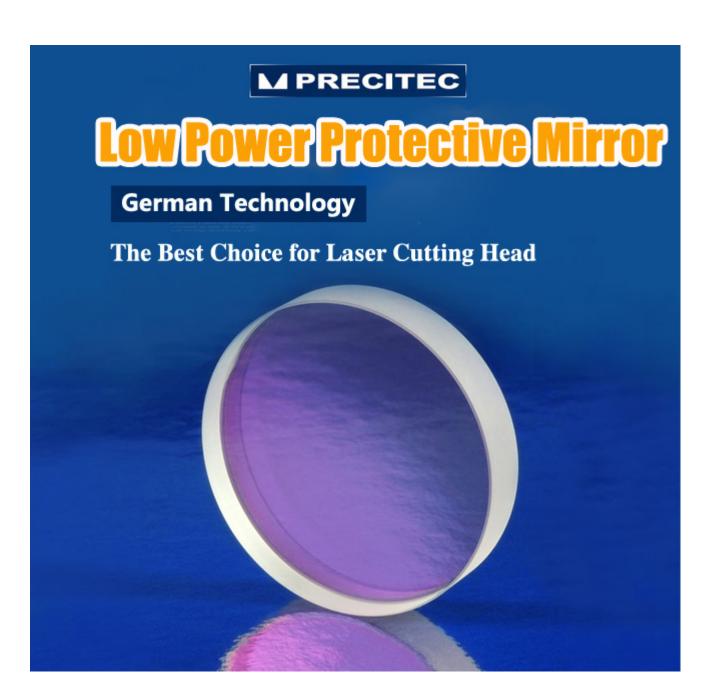
High Precision of Production

No Seams in the Cavity of Cutting Head

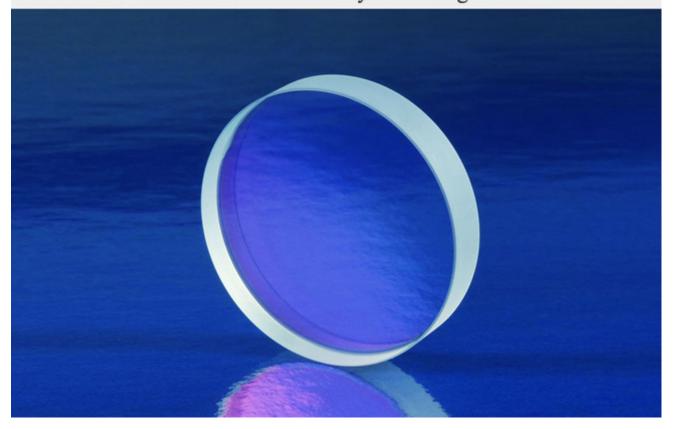
High Mechanical Strength

The lens with high mechanical strength can stand with high power of laser beam.

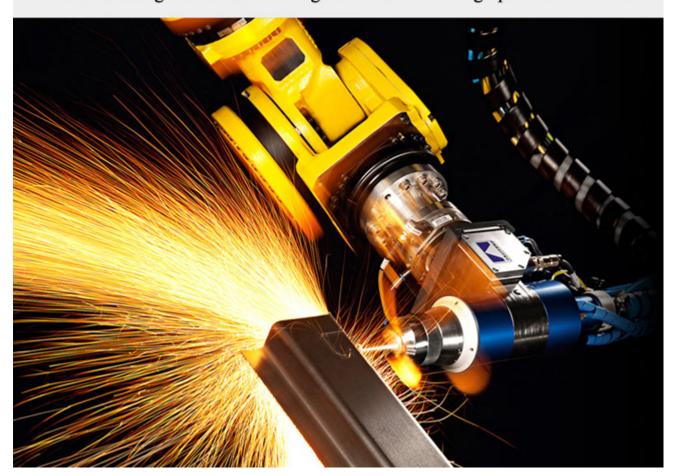
It is dust-free and avoids its focus shaking during cutting as it influences the cutting quality.

Using poor quality protective lens will not only influence its cutting quality but also it is easy to damage the focusing lens. When we do maintenance service for customers, it often happens that there is dust entered the cavity due to poor quality of lens size which results the lens burned (as shown in the red circle on the photo right)

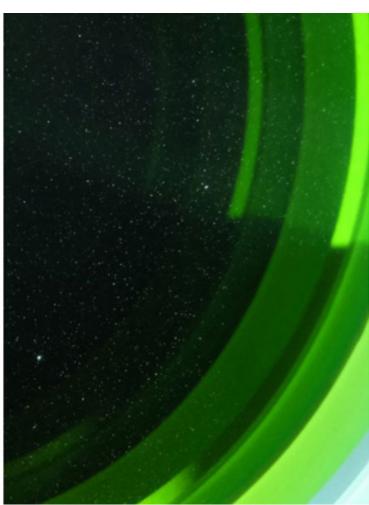
Poor Quality of Media Coating

- 1. Poor quality of media coating will cause the lens easy to be burned by metal spark flyings.
- 2. Poor precision of lens where there is dust easier entering the cavity of cutting head will cause focusing lens damage.
